## EVALUATION OF POWDER PROCESSED TURBINE ENGINE BALL BEARINGS

UNITED TECHNOLOGIES CORPORATION  
Pratt & Whitney Aircraft Group  
Government Products Division  
West Palm Beach, Florida 33402

Technical Report AFAPL-TR-77-26  
Interim Report for Period May 1975 - December 1976

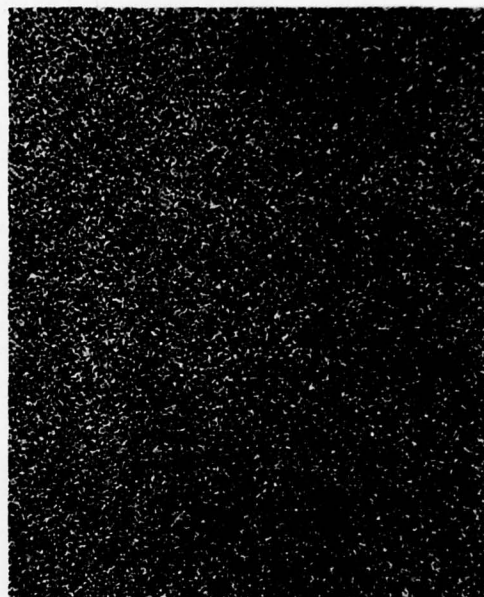
**MAGNIFICATION 100X  
PICRAL & HCL ETCHANT**

*Figure 10 P/M AISI T-15 After 2150°F/15KSI Hip Operation and Sub-critical Anneal. Carbides are more numerous in this alloy. Carbide size and distribution are evident in the 500X illustration. The dark spots are thought to be tungsten-rich regions.*

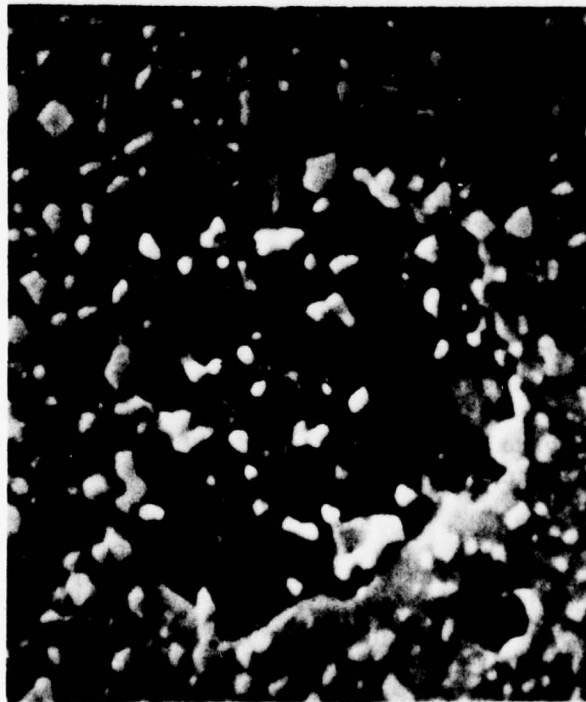
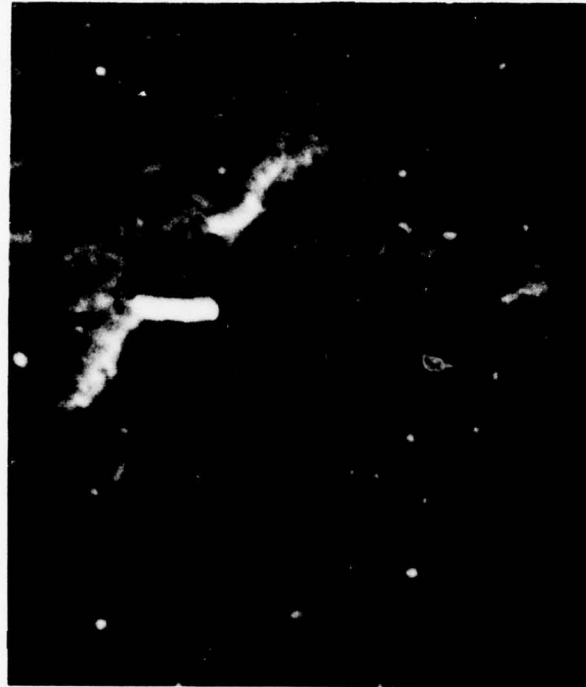
Figure 12 Scanning Electron Micrographs. Typical spherical aluminum oxide inclusion, left photograph, observed in T-15 alloy, and typical angular silicon oxide inclusion, right photograph, observed in EX00007 alloy.

The observed inclusions were identified as silica or alumina by electron microprobe analysis. Figure 12 presents scanning electron micrographs of the two types of inclusions. The largest inclusion dimension was 0.00075 inch. To put this cleanliness level in perspective, conventional vacuum melt material specifications allow a J-K rating of 1 for alumina/silicate inclusions with particle size width of 0.0005 inch and length up to 0.010 inch. Jernkontoret Standards specify that the materials be viewed at a magnification of 100X when the cleanliness value is assigned. Photomicrographs of the subject materials taken at 100X did not adequately magnify the inclusions to allow proper identification and sizing. Figure 13 is an example of alloy appearance at 100X. Therefore, additional photomicrographs were taken at 500X. Regions which were considered to contain inclusions of the largest size were photographed to demonstrate that even these areas met the J-K Standards for a rating of 1/2. Figures 14, 15 and 16 are illustrations of transverse and longitudinal sections of the three alloys. Figure 17 presents the microstructures of the three alloys as they appear in the annealed state. These photomicrographs were taken at 1000X to enlarge the carbides for closer examination. The carbides are estimated conservatively to be half the size of what is typically obtained when the alloys are conventionally processed.

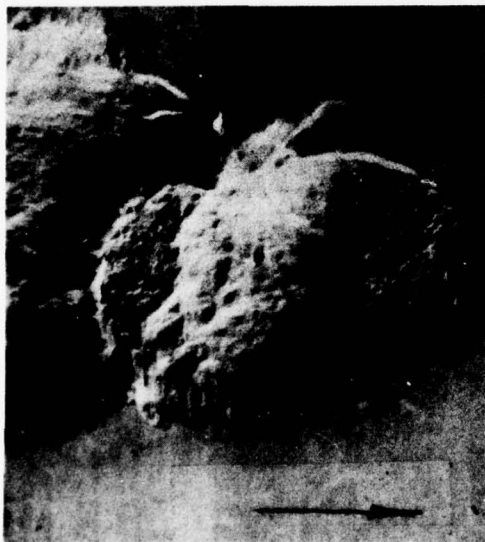
Figure 35 Typical Ball Spall. Rolling contact fatigue failure is typified by small metal chips flaking from the ball surface. Cracks originate either at a surface or sub-surface defect and under the influence of alternating stress modes, either compressive or tensile, cracking propagates until a critical size is reached and a metal chip falls away. Cracking continues at the leading edge of the spall, as shown in the right hand photo, and contributes to the propagation of spall damage. Arrow indicates leading edge of the spall.

Ball failure; that is, spalling of the ball surface as illustrated in Figure 35, or successful completion of a 40 hour test period constitutes termination of a test. After completion of at least ten tests, or as many as twenty, for a given ball lot the data are reduced by Weibull analysis techniques. This is done to determine the B-10 fatigue life of either the subject ball material, the ball processing method or the test lubricant.

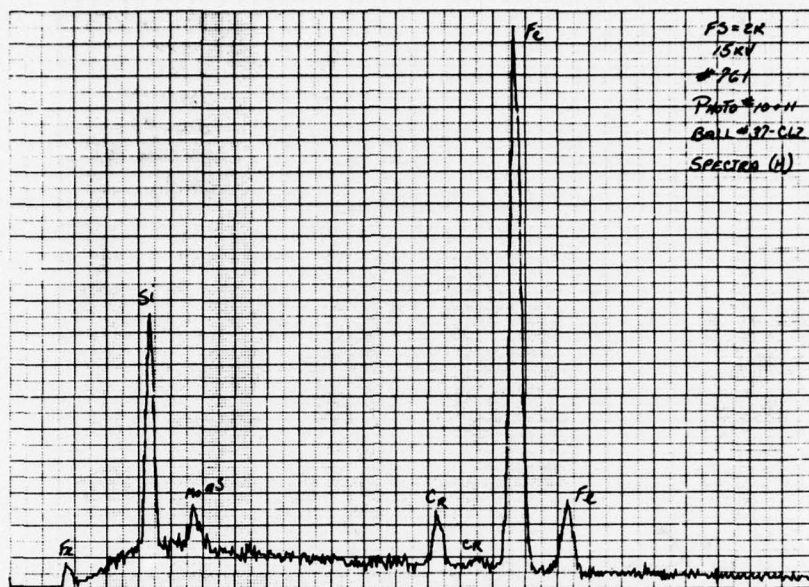
Figure 51 Electron Microprobe Trace P/M M-50 Ball S/N 37. This trace revealed the presence of silicon. This ball spalled after 108.7 million stress cycles.

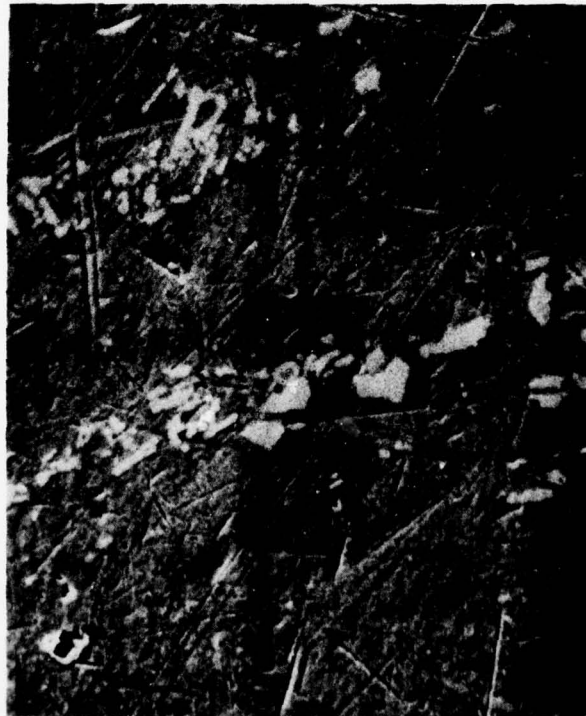
MAGNIFICATION 1000X

Figure 62 *Photomicrograph of VIM-VAR M-50 Ball, S/N 23. Carbide stringers observed outside the wear track. The larger carbides are approximately 5X the size of the carbides in the powder processed alloys. A fractured carbide is evident in the lower left corner.*

The specific VIM-VAR M-50 balls studied and reported in this section are indicated in Table 12. Again examination of both the short and long lived balls revealed no differences in the characteristics of either the wear track surface or the region in and around the spall area. This material exhibited larger carbides than observed in the powder processed alloys. They also appeared as stringers which can be seen in Figure 62. Investigators in the bearing field have observed that premature failures occur when excessively sized carbides and/or stringers of carbides exist in the bearing contact zone. An example of an incipient spall associated with a large carbide on a VIM-VAR M-50 ball surface is presented in Figure 63. The high incidence of spalls associated with large carbides has been the primary reason behind the efforts in the bearing steel preparation field to refine alloy carbides. This contract is part of that effort since powder processed metals provide the ultimate in carbide refinement and distribution.
